An uncommon cause of cemented unicompartmental knee arthroplasty failure: fracture of metallic components

Abstract

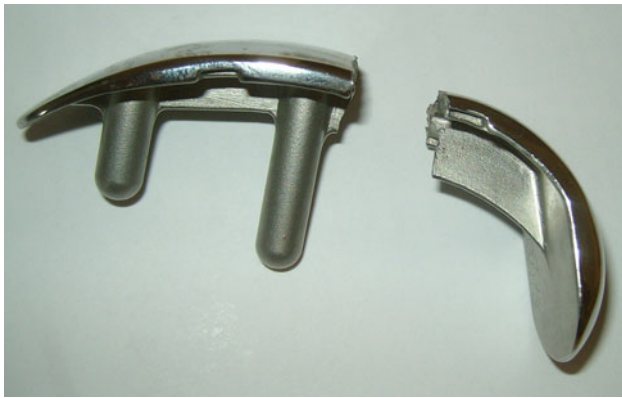
All 3 UC-plus femoral component fractures occurred in the anterior half of the implant, while the Allegretto component fracture occurred in the posterior half of the implant (Fig. 1). In all cases, the femoral implant fracture occurred close to a femoral peg. The posterior half of the tibial component fractured in both patients and in each case, this was associated with macroscopic polyethylene wear (Fig. 2). Three of the broken femoral components were made of CrCoMo and one was manufactured in titanium (Allegretto; Fig. 3). Intraoperatively, according to the Anderson Orthopaedic Research Institute Bone Defect Classification, osteolysis was grade I in the femoral and grade II in the tibial cases.

Fig. 1 Fracture of the posterior aspect of the femoral implant adjacent to the peg

All the cases of femoral component fracture were referred to us before 2003 and all occurred within 3 years of implantation. In none of these cases was evidence of either bone loss or component wear seen. The femoral component failed in the anterior half of the implant in both the UC-plus and St George Sled implants, while the posterior half was involved in the Allegretto prosthesis. In all cases, the femoral component fracture occurred close to a femoral peg despite no signs on the pre-failure radiographs of any component malpositioning. Interestingly, the more recent implants included in the study have been modified with wider femoral fins, and we have seen no further component fractures.

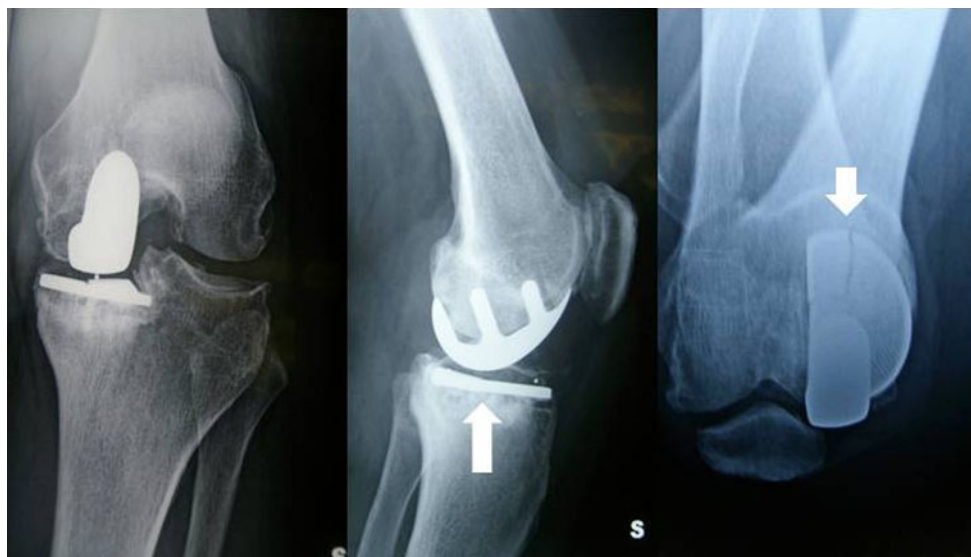
Fig. 2 Fracture of a finless titanium tibial component

Compared with the femoral component fractures, both tibial failures in our study occurred later (mean 8.5 years). In both cases, evidence of polyethylene wear, metallosis and osteolysis was seen. Despite different metallic compositions (CoCrMo or titanium), both the tibial component fractures were localized to the posterior half of the implant suggesting stress concentration during knee flexion and extension resulted in fatigue failure. The role of malalignment in the tibial implant fractures could not be accurately assessed, as the HKA immediately after UKR implantation was available in only 1 patient. In neither case of tibial component fractures was an excessively thick polyethylene liner implanted.

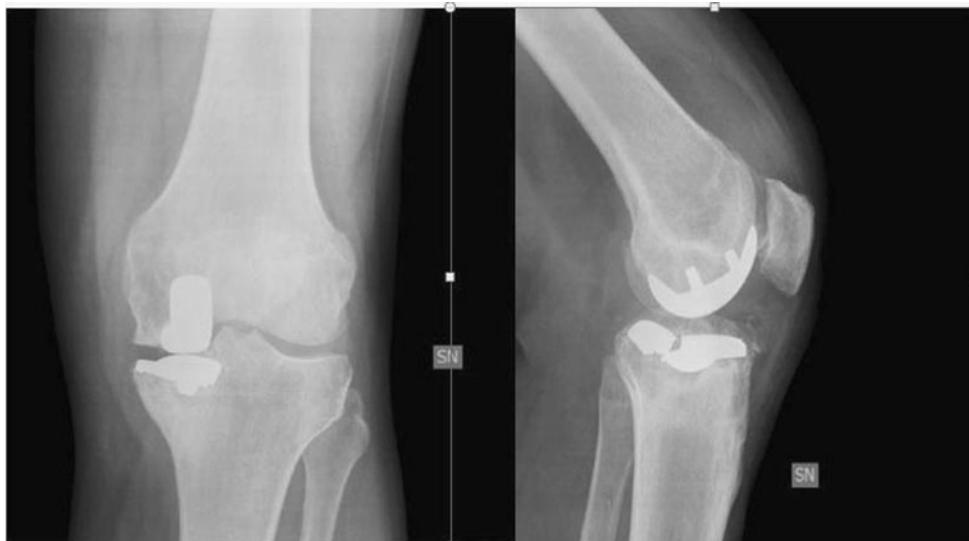
Fig. 3 Fracture of a CrCoMo tibial component with bone loss
